# MATERIALS ENGINEERING LABORATORY REPORT

Process parameters validation [Redacted] of CV joint [Redacted] heat treatment. Six monoblock shaft samples were submitted for metallurgical analysis.

**SUMMARY:** All samples meet hardness and depth of hardening requirements. S/N 3 and S/N 5 exhibit evidence of tempering while S/N 1 does not. Hardness profiles indicate that tempering affected the surface hardness. No notable differences in surface characteristics were noted between the two tempering methods (S/N 3 and S/N 5). See Data Summary.

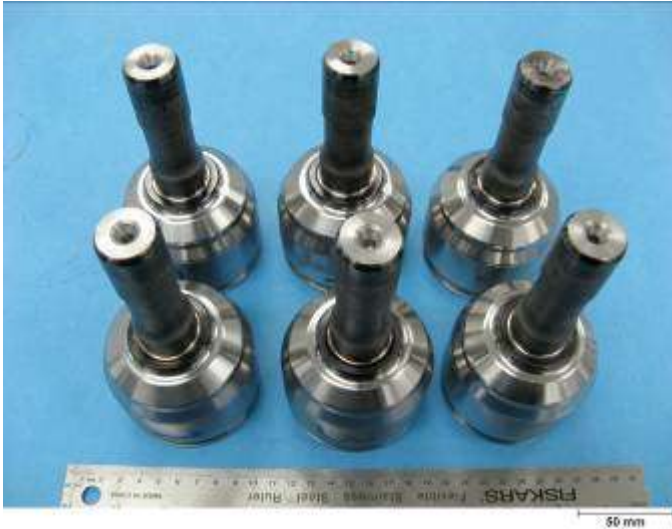
Figure 1- S/N 1-2 (left), S/N 3-4 (center), and S/N 5-6 in as-received condition. (0.3X)

Six CV joint monoblock shafts were submitted to the CML in the non-tested condition shown in Figure 1. The splines were not rolled and the ball tracks were neither machined nor heat treated. Weld spatter was noted on S/N 6. The origin of this spatter is unknown. S/N 1, S/N 3, and S/N 5 were evaluated as representative samples. See Figures 2-3.

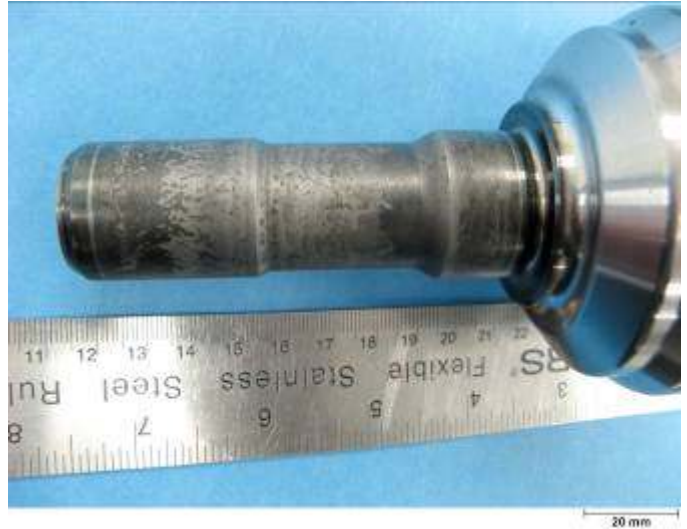
Figure 2- Visible heat pattern on all samples. (0.75X)

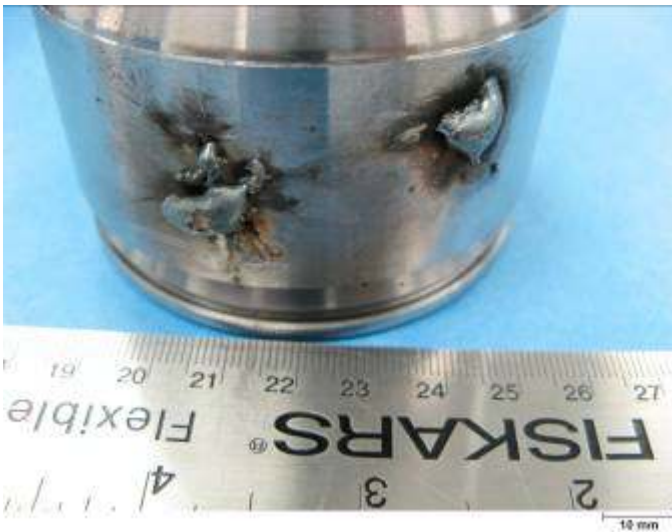
Figure 3- Weld spatter noted on S/N 6. (1X)

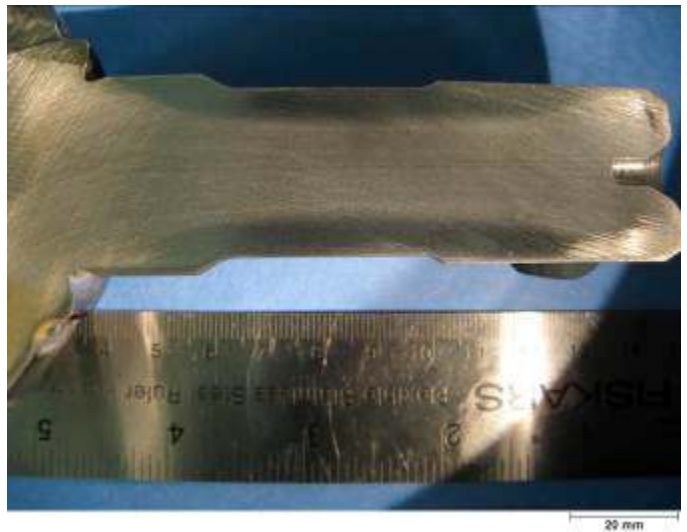
Figure 4- Representative induction pattern noted on all samples. (0.85X)

Longitudinal sections were removed from the examined samples and etched with 2% nital to view the pattern. The pattern on all samples looked typical except for the lack of heating in the fillet region. See Figures 4 for a representative image. Effective case depths (to 50 HRC) were obtained from the body location using a Vickers microhardness indenter and a 500g load in accordance with ASTM E384. These results are listed in Table 2. Profiles and their corresponding values are shown in Figures 5-8 and Tables A-C respectively.

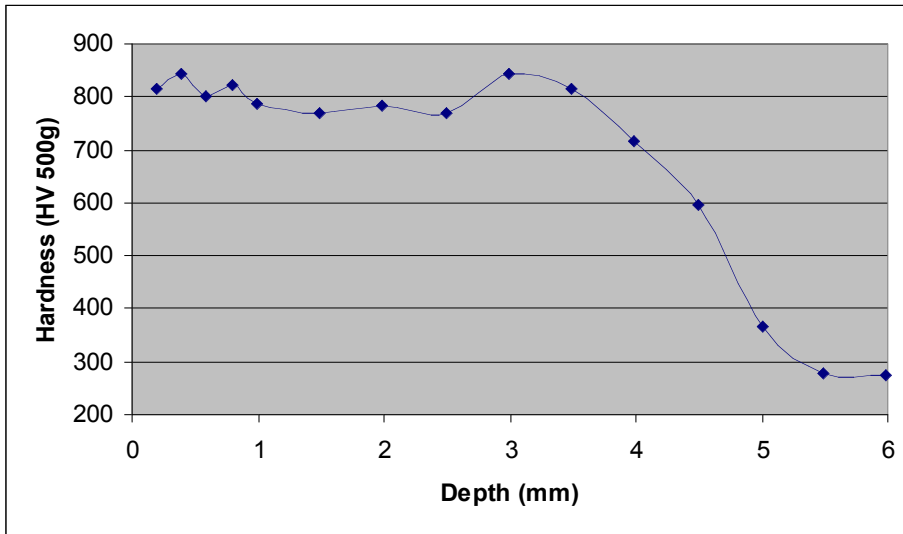
Figure 5- S/N 1 microhardness profile.

Table A- S/N 1 profile values.

Hardness	Distance	HRC
815	0.193	64.5
842	0.392	65.3
801	0.592	64
821	0.792	64.7
788	0.992	63.6
769	1.49	62.9
782	1.99	63.3
769	2.49	62.9
843	2.99	65.3
814	3.49	64.4
715	3.99	60.8
596	4.49	55.1
367	5	37.5
278	5.49	26.9
273	5.99	26.1

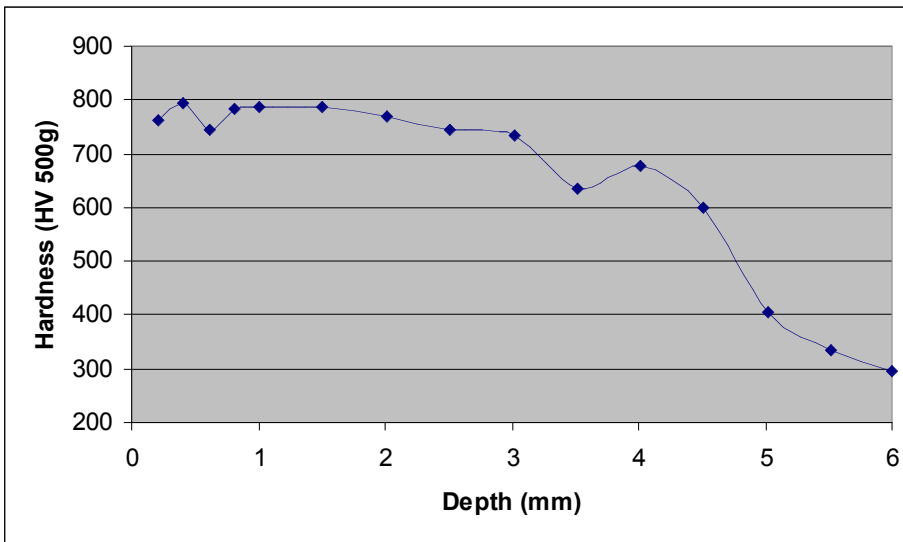
Figure 6- S/N 3 microhardness profile.

Table B- S/N 3 profile values.

Hardness	Distance	HRC
763	0.21	62.6
794	0.412	63.8
744	0.613	61.9
782	0.813	63.3
788	1.01	63.6
788	1.51	63.6
769	2.01	62.9
744	2.51	61.9
733	3.02	61.5
634	3.52	57.1
678	4.02	59.2
600	4.51	55.3
404	5.02	41.2
334	5.52	33.8
296	6.00	29.2

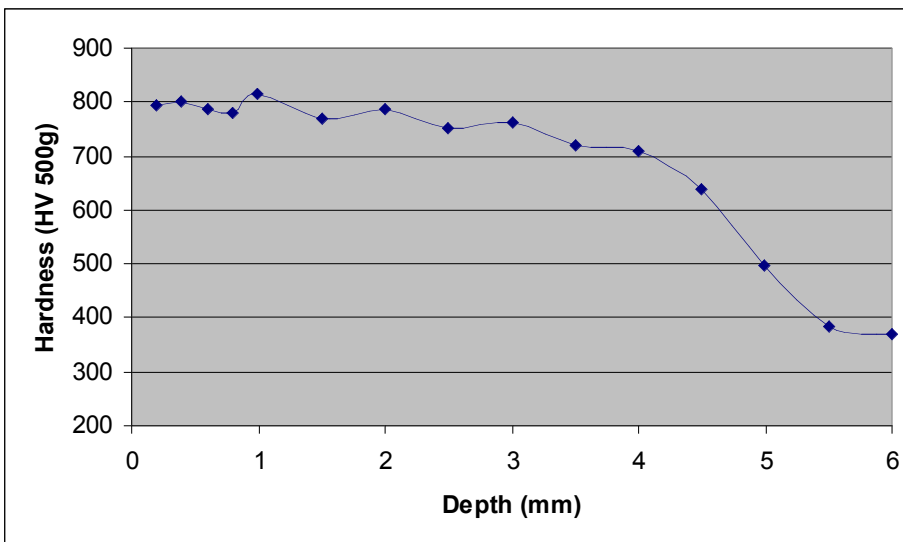
Figure 7- S/N 5 microhardness profile.

Hardness	Distance	HRC
795	0.196	63.8
801	0.396	64
788	0.596	63.6
781	0.796	63.3
815	0.997	64.5
769	1.5	62.9
788	2	63.6
751	2.5	62.2
763	3	62.6
721	3.5	61
710	4	60.6
638	4.5	57.3
497	4.99	48.9
384	5.5	39.2
368	6	37.5

Table C- S/N 5 profile values.

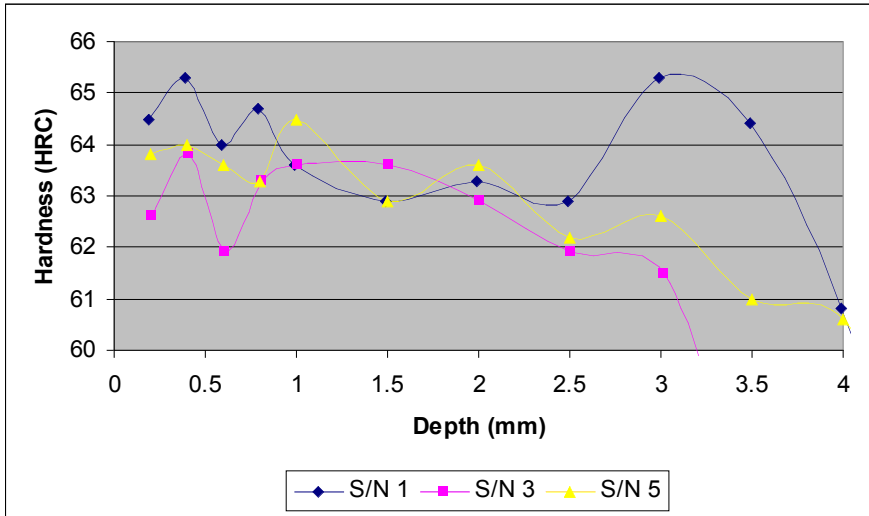
Figure 8- Microhardness profiles showing difference in temper.

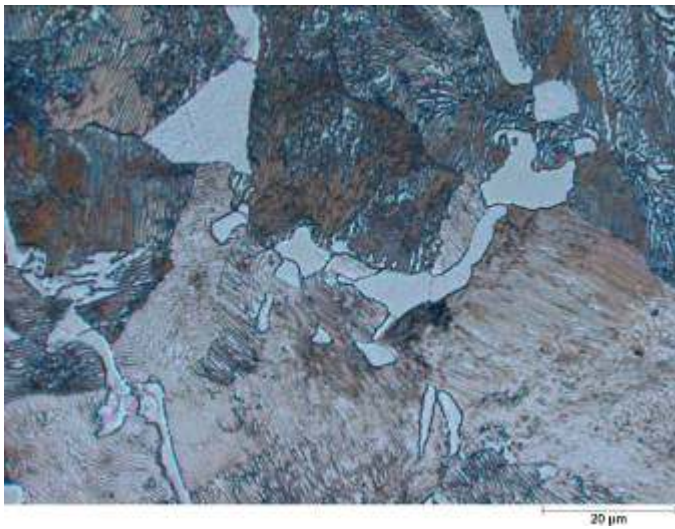
Figure 9- Representative core microstructure. 2% nital. (1000X)

Transverse cross-sections from the body of each representative sample were removed and prepared for metallographic evaluation in accordance with ASTM E3. The samples were etched with 2% nital to observe the microstructure. S/N 3 and S/N 5 exhibited a surface microstructure of tempered martensite while S/N 1 exhibited a surface microstructure of untempered martensite. All samples exhibited a core of pearlite and ferrite. See Figures 9-12.

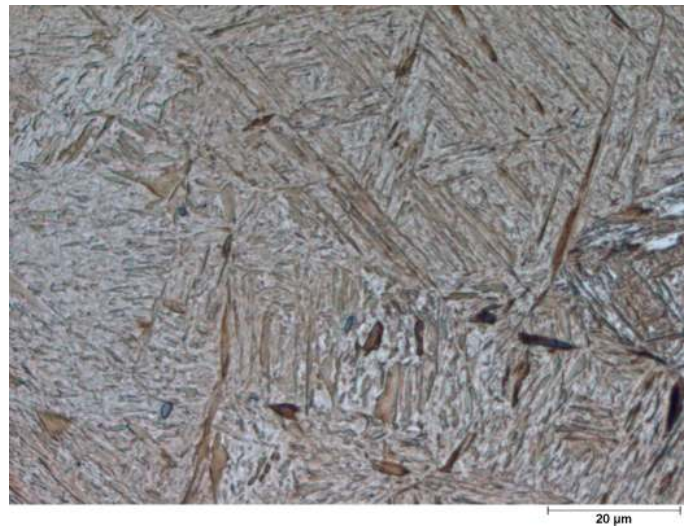
Figure 10- Surface microstructure of S/N 1 as-quenched. 2% nital. (1000X)

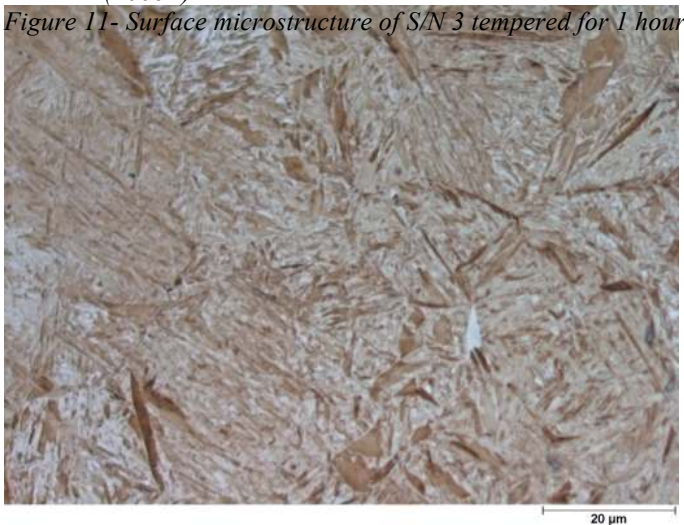
Figure 11- Surface microstructure of S/N 3 tempered for 1 hour

*At 167°C. 2% nital. (1000X)*

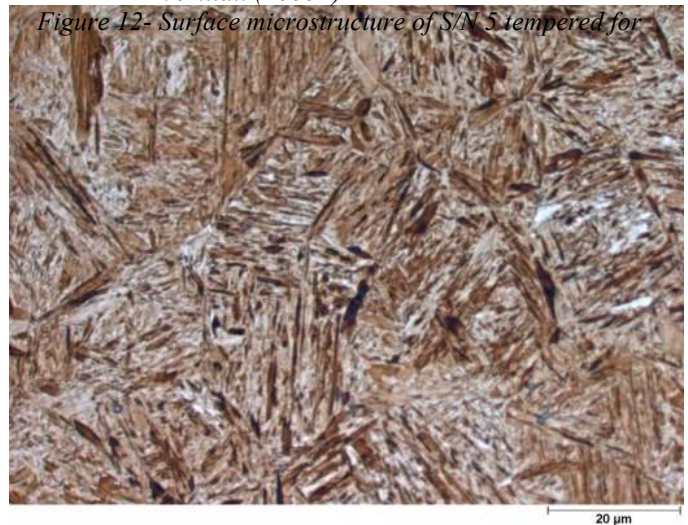
Figure 12- Surface microstructure of S/N 5 tempered for 1 hour

*20 min. at 167°C. 2% nital. (1000X)*
